Talking with Patients

Dental Amalgam

André V. Ritter, DDS, MS

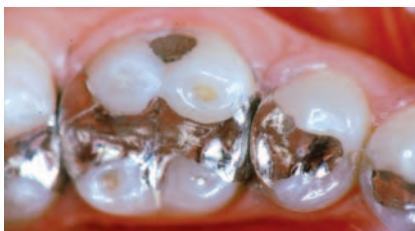
The following photograph contains examples of amalgam restorations.
